by Mike Brown
members.atra.com
www.atra.com

Toyota's A750E

Neck Breaking Engagement

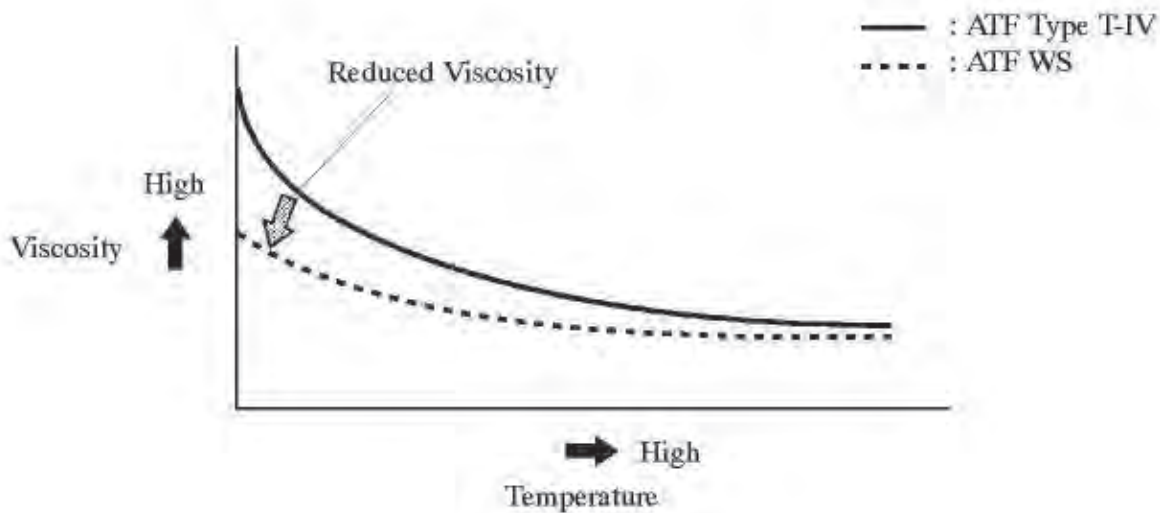
Figure 5

One thing to keep in mind when working on an A750E is fluid type. Toyota recommends genuine ATF WS to reduce the drag and improve fuel economy. This ATF has reduced viscosity in the practical operating temperature range (figure 5).

At higher-fluid temperatures, the viscosity is the same as Toyota ATF T-IV, to ensure the transmission's durability.
